Advanced Materials Manufacturing & Characterization

Effect of Notch Orientation, Temperature and Filler Material on Impact Toughness of GFRP Composites

K Sadashivappa, M.C.Murugesh

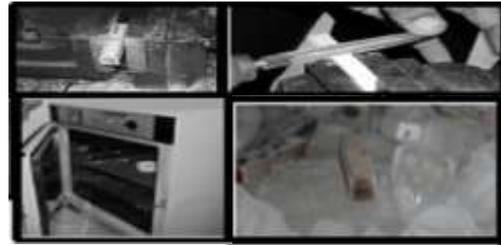
Figure 2. Notching and maintaining specimen to different temperatures

After curing of the specimen they were cut to size as per ASTM standards and notch across and along the laminates were made. Specimens were kept in freezer and electric oven to maintain different temperatures as shown in Figure 2. Specimens were tested on a pendulum type impact testing machine, under different temperatures, 0°C, room temperature (34°C) and 60°C. The amount of energy absorbed by the specimens before it breaks is directly obtained from a graduated scale provided in the impact testing machine. Impact strength is calculated on the

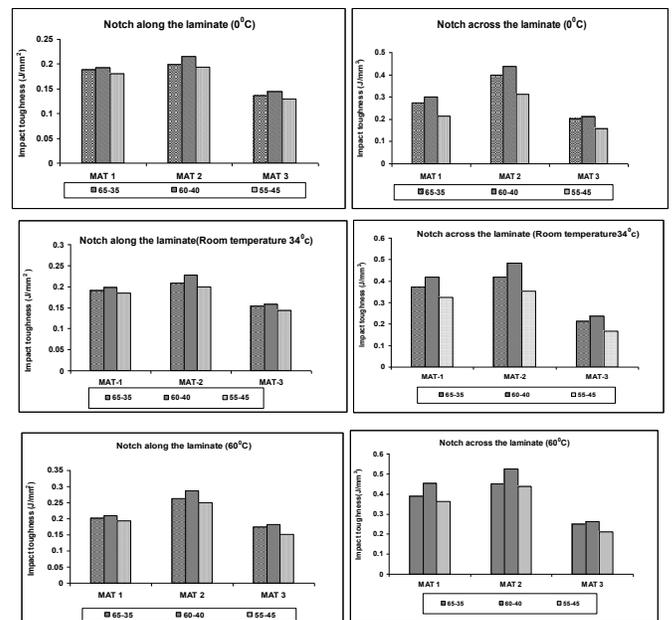
Figure 3. Effect of fabric volume, Notch orientation and temperature on the impact toughness

In order to determine the effect of fabric content on the impact toughness, the test coupons were prepared with three different volume fractions. Also, to identify the effect of service temperature on the impact toughness, the specimens were impact tested under three different temperatures. Figure 3 shows the results of the impact testing carried out on these test coupons.

As can be seen from the Figure 3, it is very much clear that the impact toughness of the test coupons with the notch grooved across the laminates is higher than that of the coupons with the notch along the laminates, irrespective of the volume fraction. We can also observe that impact toughness is increasing as volume fraction of GF increases but has decreased for 65%. The three main mechanisms identified to be responsible for the increase or decrease in the impact toughness in these composites are: (a) fracture and failure of fabrics; (b) fractional sliding that takes place in the fiber matrix interface as fiber pull out during failure and (c) matrix cracking or deformation of matrix in shear and transverse tension/compression. In the case of notch along

the laminates the failure is mainly because of the debonding of the laminates at the interface. A shear failure is observed in the glass fibers.

In order to determine susceptibility of these composites to the service temperatures, the test coupons were impact tested under different temperatures at 0°C and 60°C. Figure 3 shows the variation of impact energy with reference to these temperatures. It can be very clearly seen from Figure 3 that there is change in the impact toughness with service temperature. It can also be seen from the figure, that the increased volume of glass has increased the impact toughness of this composite, irrespective of service temperature. The increase in the impact toughness for all three types of specimens is achieved with increased service temperature. The same behavior is observed in the specimens with both the types of notch orientation.

The increase in the impact toughness with increase in service temperature is mainly because of the increase in the bonding strength with increased temperatures. But at higher temperature the brittle polymer epoxy matrix will get fused, leading to the debonding of the laminate. Because of this debonding the impact toughness of these test coupons at elevated temperatures is found to be less.

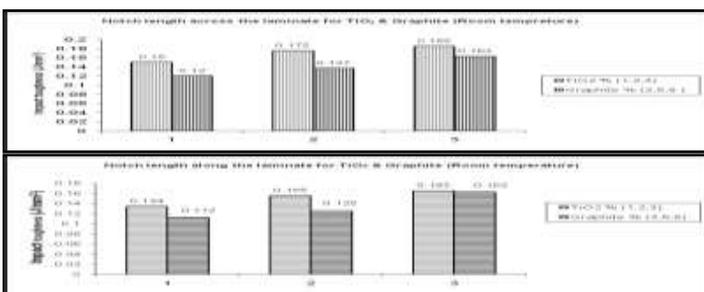
The Impact Toughness

By the addition of filler material like TiO₂ and Graphite an observation could be made from the figure 4 that notch grooved across the laminates is higher than that of the specimens with the notch along the laminates holds good, also second observation was, as the percentage of filler material increases, the impact toughness values also increases which shows that the filler material has bonded itself into the matrix of fiber and thereby toughness sustainability has increased, lesser the percentage has decreased the toughness value because of the gap in fabric matrix. When compared, specimens with TiO₂ as filler showed tougher value than that of graphite filled specimens. This is due to grain size and bondability aspect of the filler material.
